Manhole Inspection Summary

Manhole # S25I__053MH

Insp Date: **3/17/08 10:56 AM**

Location Address: **1301 LEMMON ST.**

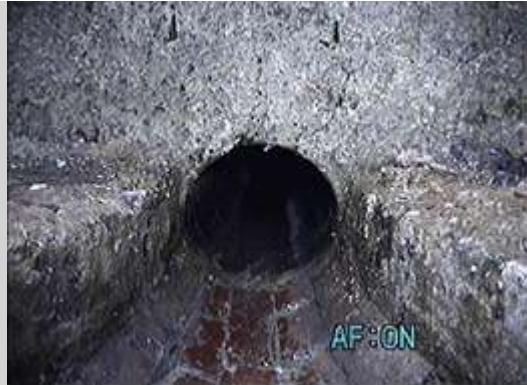
12 O'Clock Outflow

Pipe Height: **8.4** (in.) Rod and Bar (Angled)
Pipe Material: **Clay** ☐ Pipe Lined
Invert Depth: **9.85** (ft.) Flow Characteristics: **Fast**
Deposits: ☒ None ☐ Mud ☐ Sludge ☐ Debris ☐ Grease
Silt Depth: **0** (in.) Deposits Extent:
Infiltration: **None** Pipe Seal Cond: **Unknown**

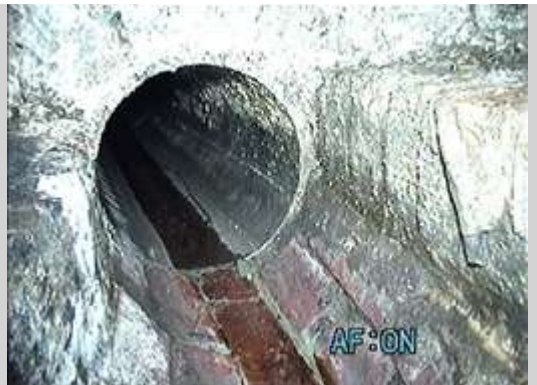
3 O'Clock Inflow

Pipe Height: **8.4** (in.) Rod and Bar (Angled)
Pipe Material: **Clay** ☐ Pipe Lined
Invert Depth: **9.52** (ft.) Flow Characteristics: **Fast**
Deposits: ☒ None ☐ Mud ☐ Sludge ☐ Debris ☐ Grease
Silt Depth: **0** (in.) Deposits Extent:
Infiltration: **None** Pipe Seal Cond: **Sound**

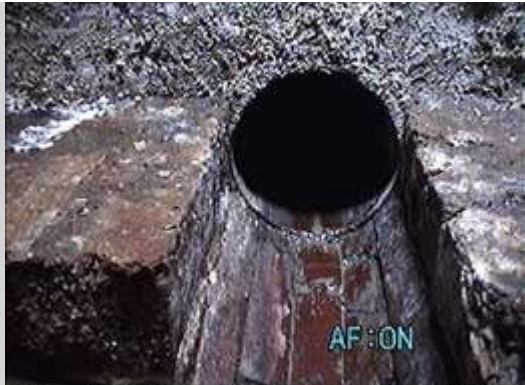
6 O'Clock Inflow

Pipe Height: **8.4** (in.) Rod and Bar (Angled)

Pipe Material: **Clay** ☐ Pipe Lined

Infiltration: **None** Pipe Seal Cond: **Sound**
